NBSIR 82-2465

Investigation of the Kansas City Hyatt Regency Walkways Collapse

February 1982

**INVESTIGATION OF THE KANSAS CITY
HYATT REGENCY WALKWAYS COLLAPSE**

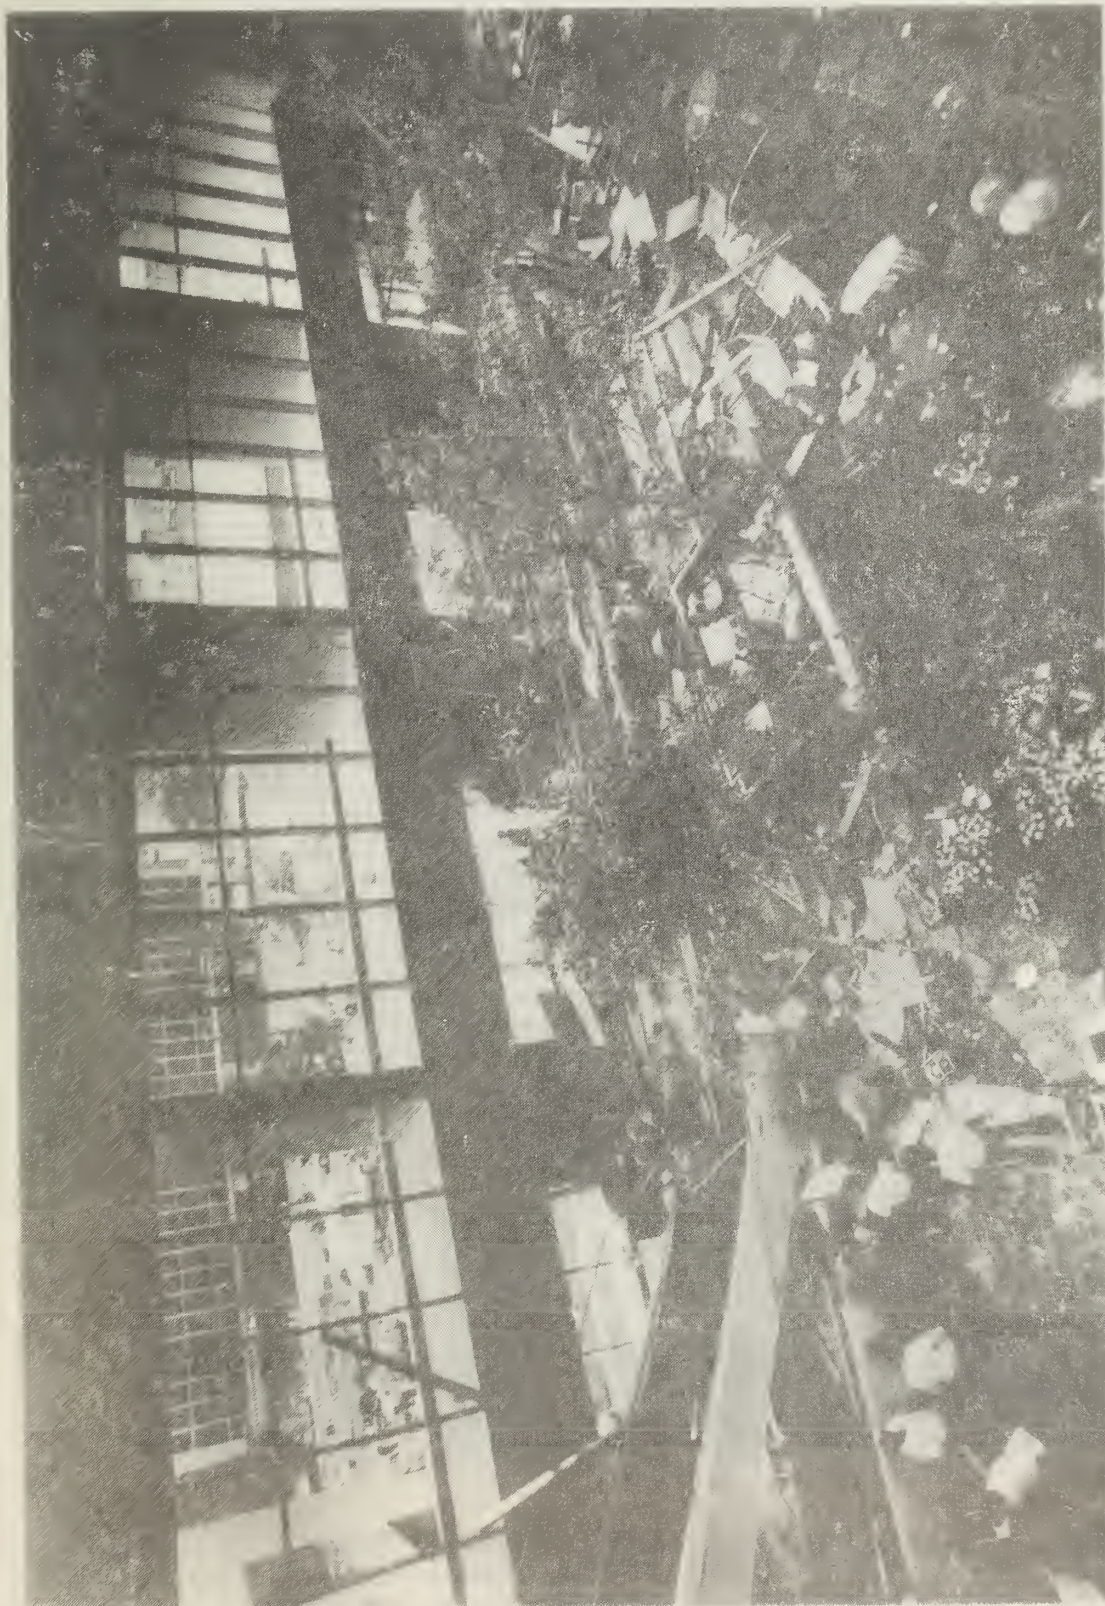
Figures 4.1 and 4.2 show the walkways shortly after the collapse, just as the rescue operation was getting under way. The photograph in figure 4.1 appears to have been taken from the stairway landing at the south side of the atrium between the second and third floors. The view is to the west-northwest and shows part of span U7-8 which lodged in the second-floor portal originally occupied by span L7-8. Spans U8-9 and U9-10 can be seen behind the trees in the middle of the picture. The photograph in figure 4.2 was taken from the third floor with the view directly to the north along the axis of the walkways. Span U7-8 is in the foreground and the third floor walkway can be seen to the upper right. Span U10-11 is visible at the far (north) side of the atrium. The north end of this span appears to have experienced an appreciable displacement to the west during the collapse. Water is coming from walkway sprinkler pipes severed when the north walkway spans were pulled off of their bearing seats.

Figure 4.1 Walkways shortly after the collapse. View is to the west-northwest with span U7-8 sloping down and to the right. Spans U8-9 and U9-10 are visible behind the trees. Photo by Greg Smith, reprinted by permission of The Kansas City Times, © 1981, The Kansas City Star Company.

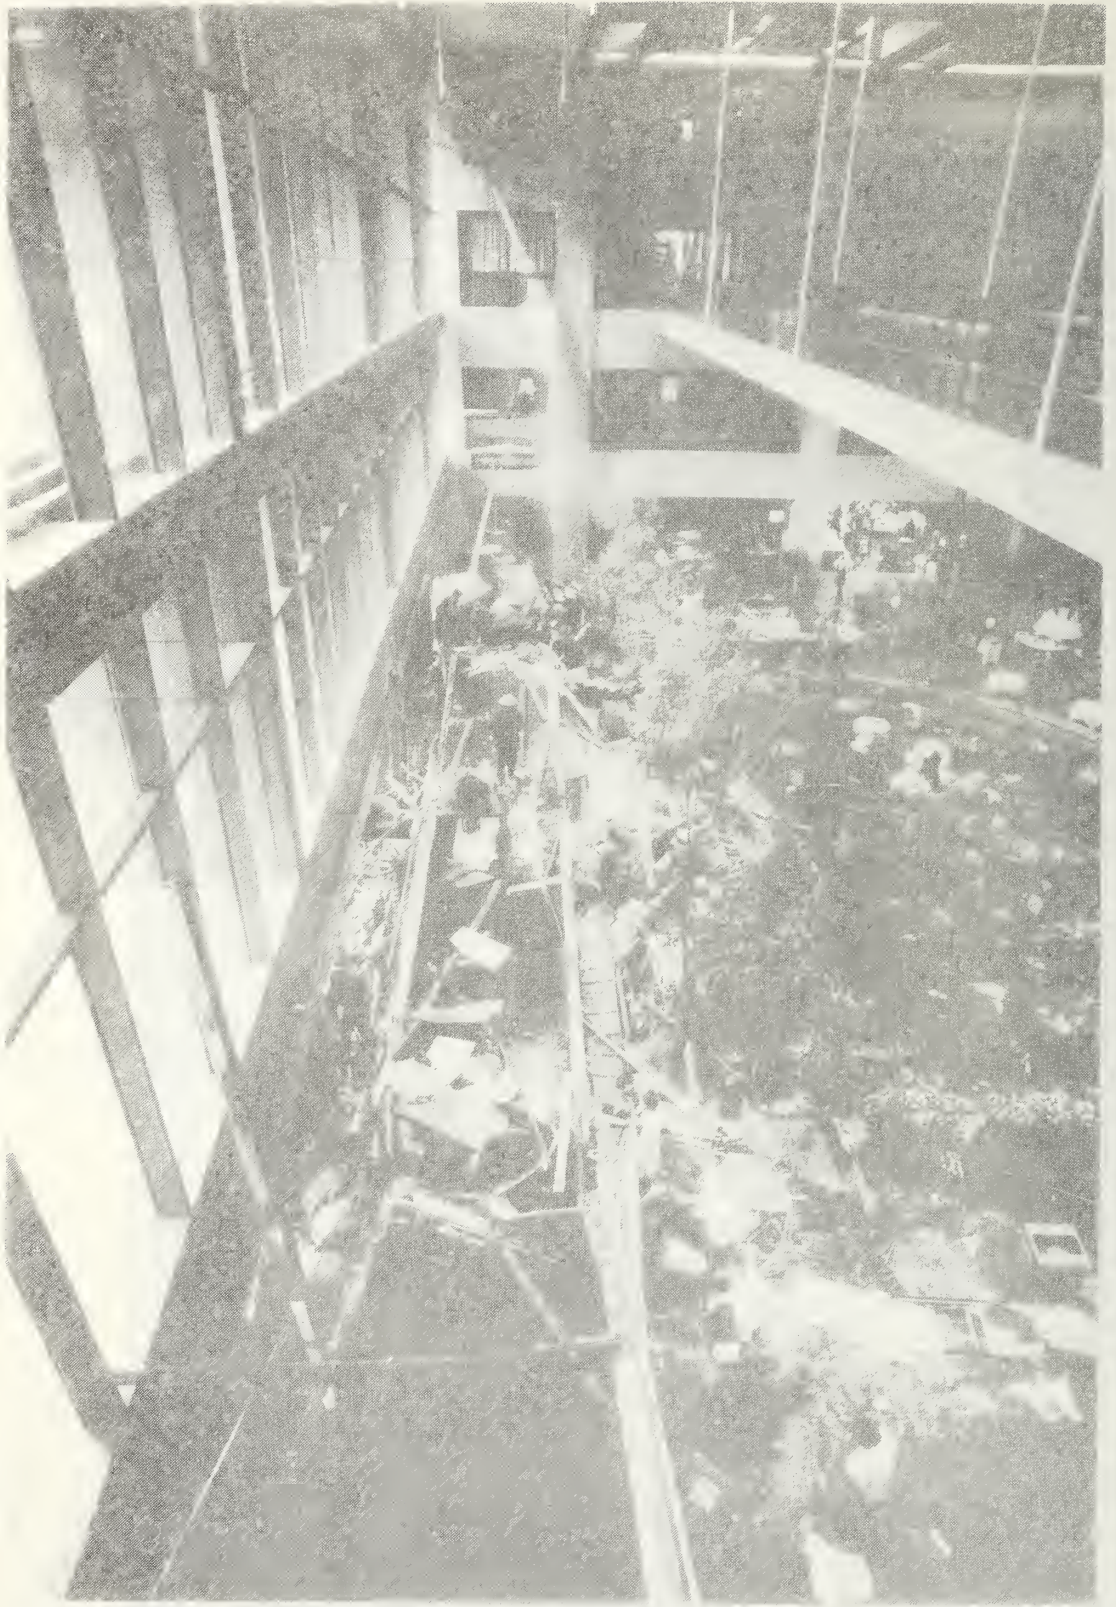
Figure 4.2 Walkways shortly after the collapse. View is directly to the north along the axis of the walkways. Span U7-8 is in foreground and third floor walkway is at upper right. Water is coming from broken sprinkler pipes. Photo by Greg Smith, reprinted by permission of The Kansas City Times, © 1981, The Kansas City Star Company.

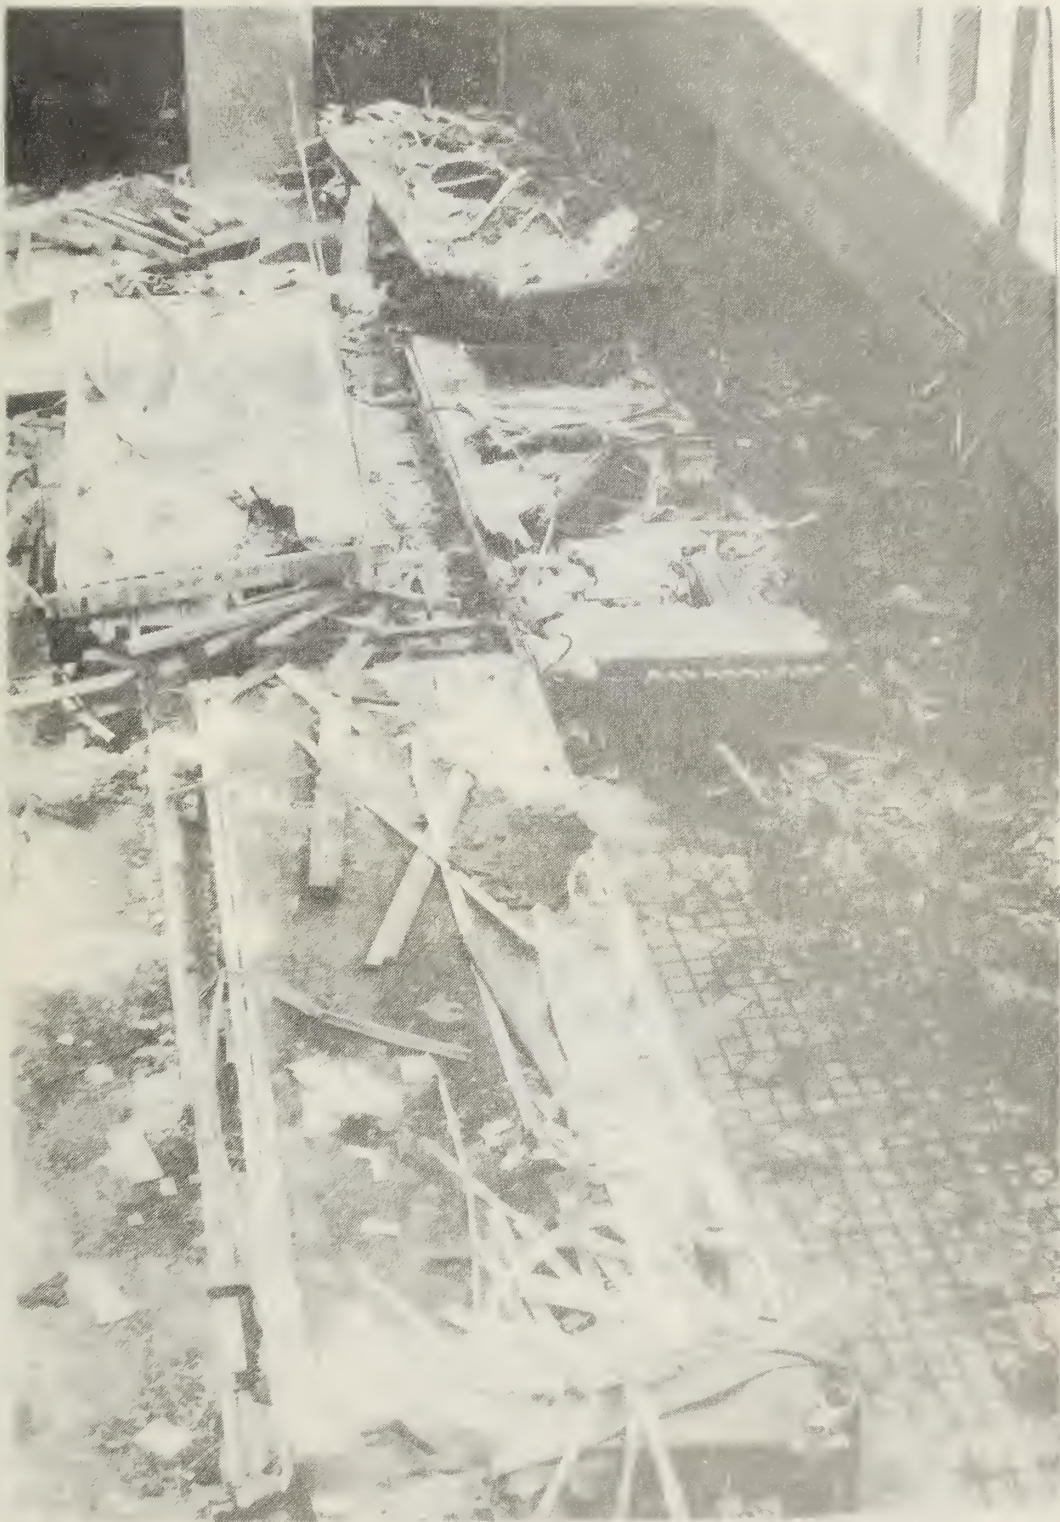
A general view of the walkway debris after all victims had been removed is shown in figure 4.3. The view is to the south and shows span L9-10 resting on span U9-10 in the foreground. Directly to the south is span U8-9 (left) and span L8-9 (right). At the upper left is the south end of span U7-8. Span L7-8 is at the top of the picture, directly below its original position in the second floor walkway. Much of the debris is timber cribbing used to support the spans during the rescue operation. Span L10-11 is out of view in the left foreground and span U10-11 has been moved through the main entrance (to the right) and into the hotel driveway.

Figure 4.3 Aftermath. View is to the south with span L9-10 resting on span U9-10 in foreground. Next are spans U8-9 (left) and L8-9 (right). Span U7-8 is at upper left and span L7-8 is at upper right. Photo courtesy of Kansas City Police Department.

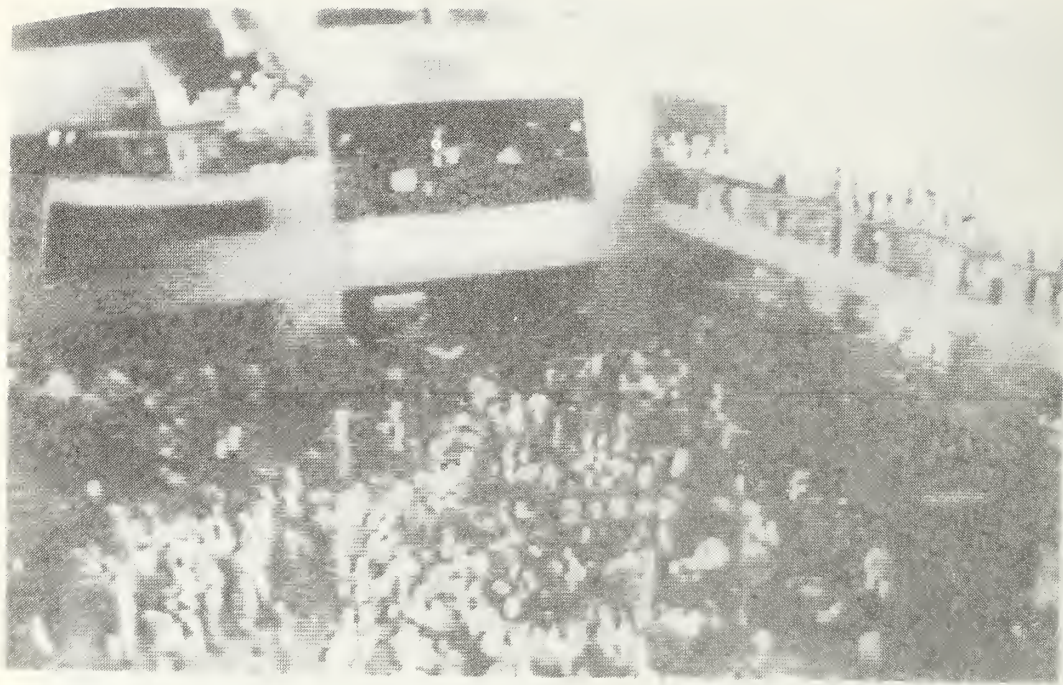
Three segments of the tape provided by KMBC TV were suitable for analysis. The scene in figure 4.4 is from the third floor balcony on the north side of the atrium with the view to the southwest. All of span L7-8 and most of span

Figure 4.4 Scene from third floor balcony on north side of atrium. View to the southwest showing spans L7-8 and L8-9 of second floor walkway. Videotape courtesy of KMBC TV.

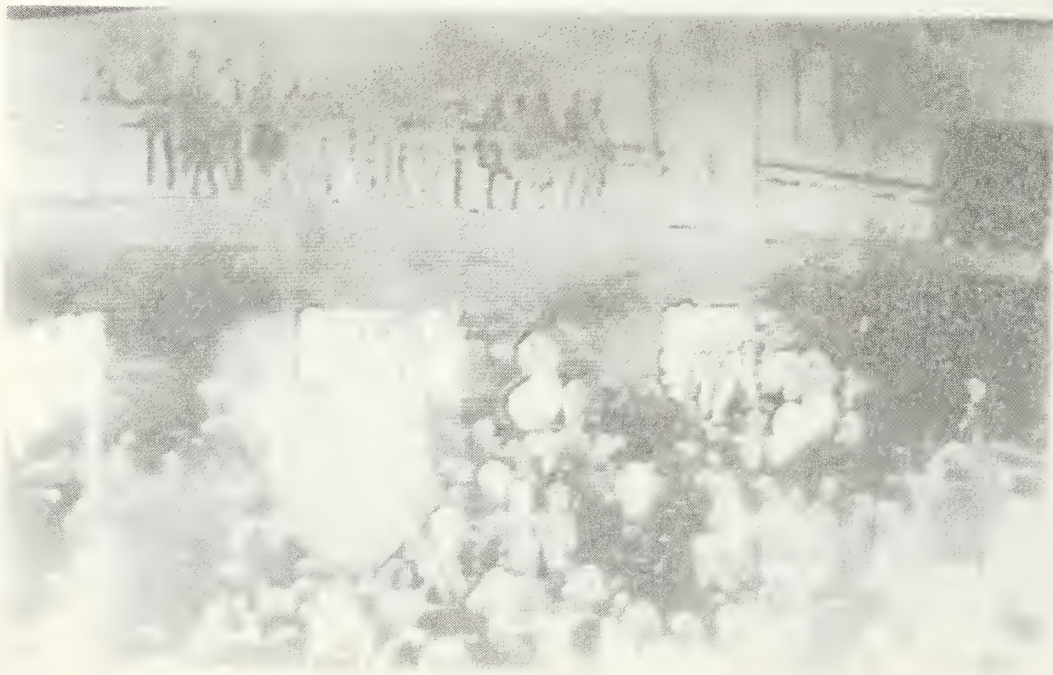
The scene in figure 4.5, believed to have been taken a few minutes after the frame shown in figure 4.4, appears to be from the landing of the main stairway in the southeast corner of the atrium, looking northwest. Part of span L8-9 and all of spans L9-10 and L10-11 of the second floor walkway are visible. Eight or nine people are occupying the south portion of span L9-10 along the handrail and span L10-11 is not occupied.

Figure 4.5 Scene from landing of main stairway in southeast corner of atrium. View to northwest shows part of span L8-9 and all of spans L9-10 and L10-11 of second floor walkway. Videotape courtesy of KMBC TV.

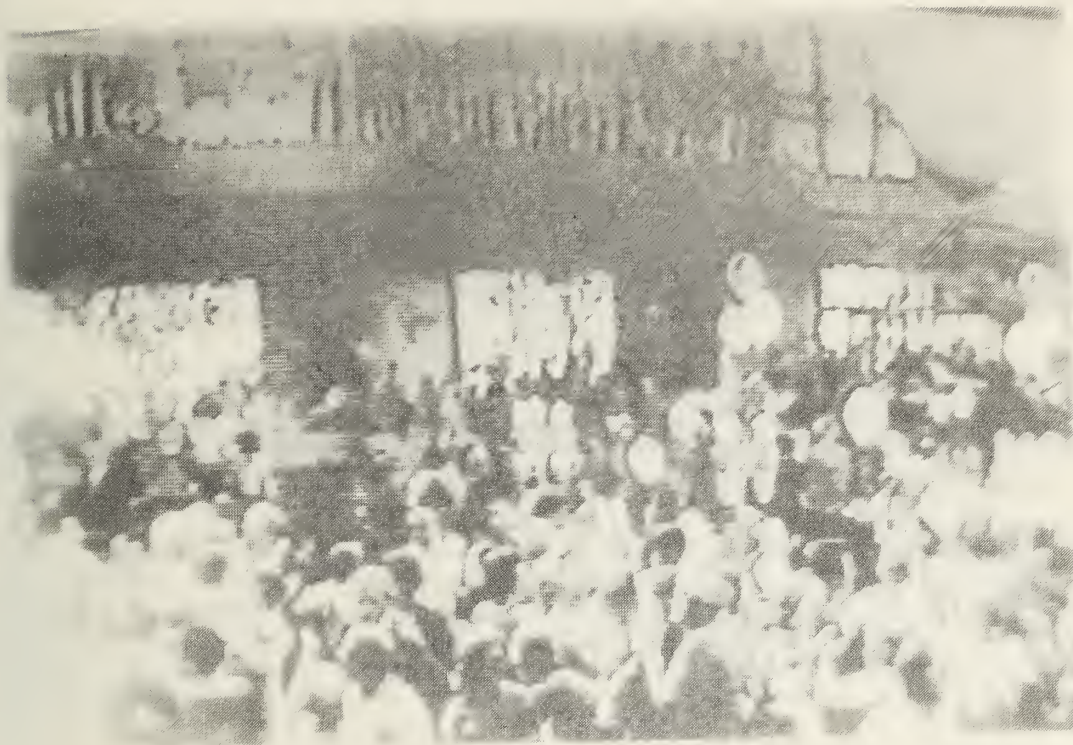
The scene in figure 4.6, taken a few frames later, appears to be from the same location as that in figure 4.5, but shows more of span L8-9. Judging from their relative heights, the people on span L9-10 have not moved from their positions shown in figure 4.5. It appears that the count on span L9-10 is now 11, but blurring makes an accurate count difficult.

Figure 4.6 Same view as figure 4.5, but a few frames later. Videotape courtesy of KMBC TV.

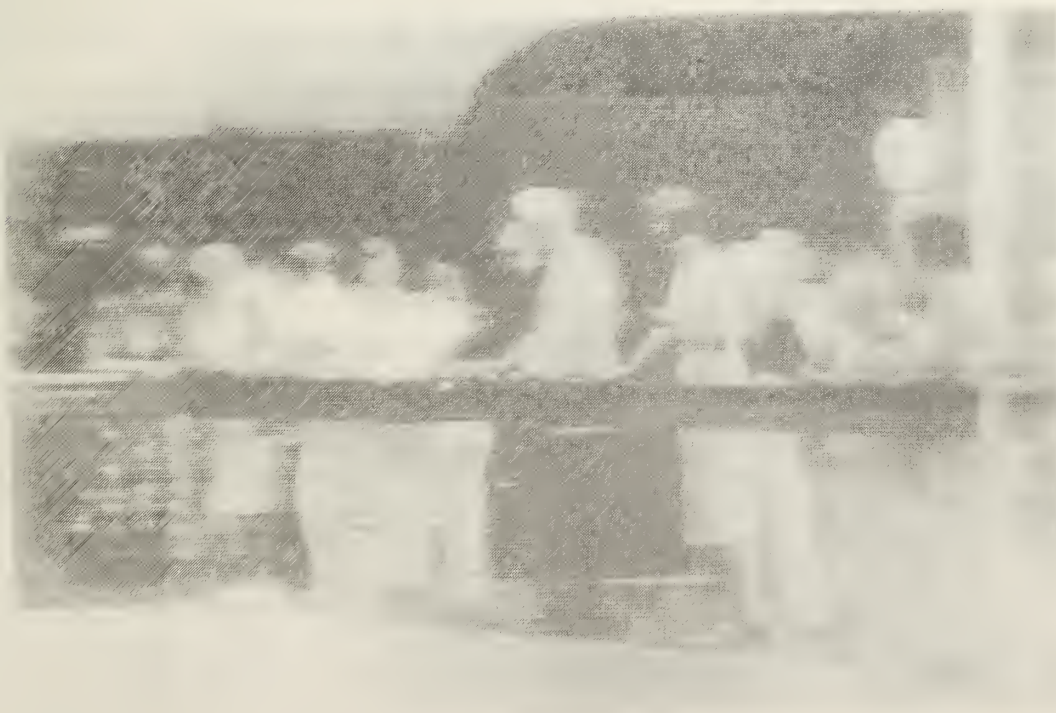
Figure 4.7 is a close-up of the southernmost span (span M7-8) in the third floor walkway. The view is from the same location as figure 4.4. Again, it is difficult to make an accurate count, but at least 11 persons can be observed.

Figure 4.7 View from third floor balcony on north side of atrium. View to southwest showing southernmost span (span M7-8) of third floor walkway. Videotape courtesy of KMBC TV.

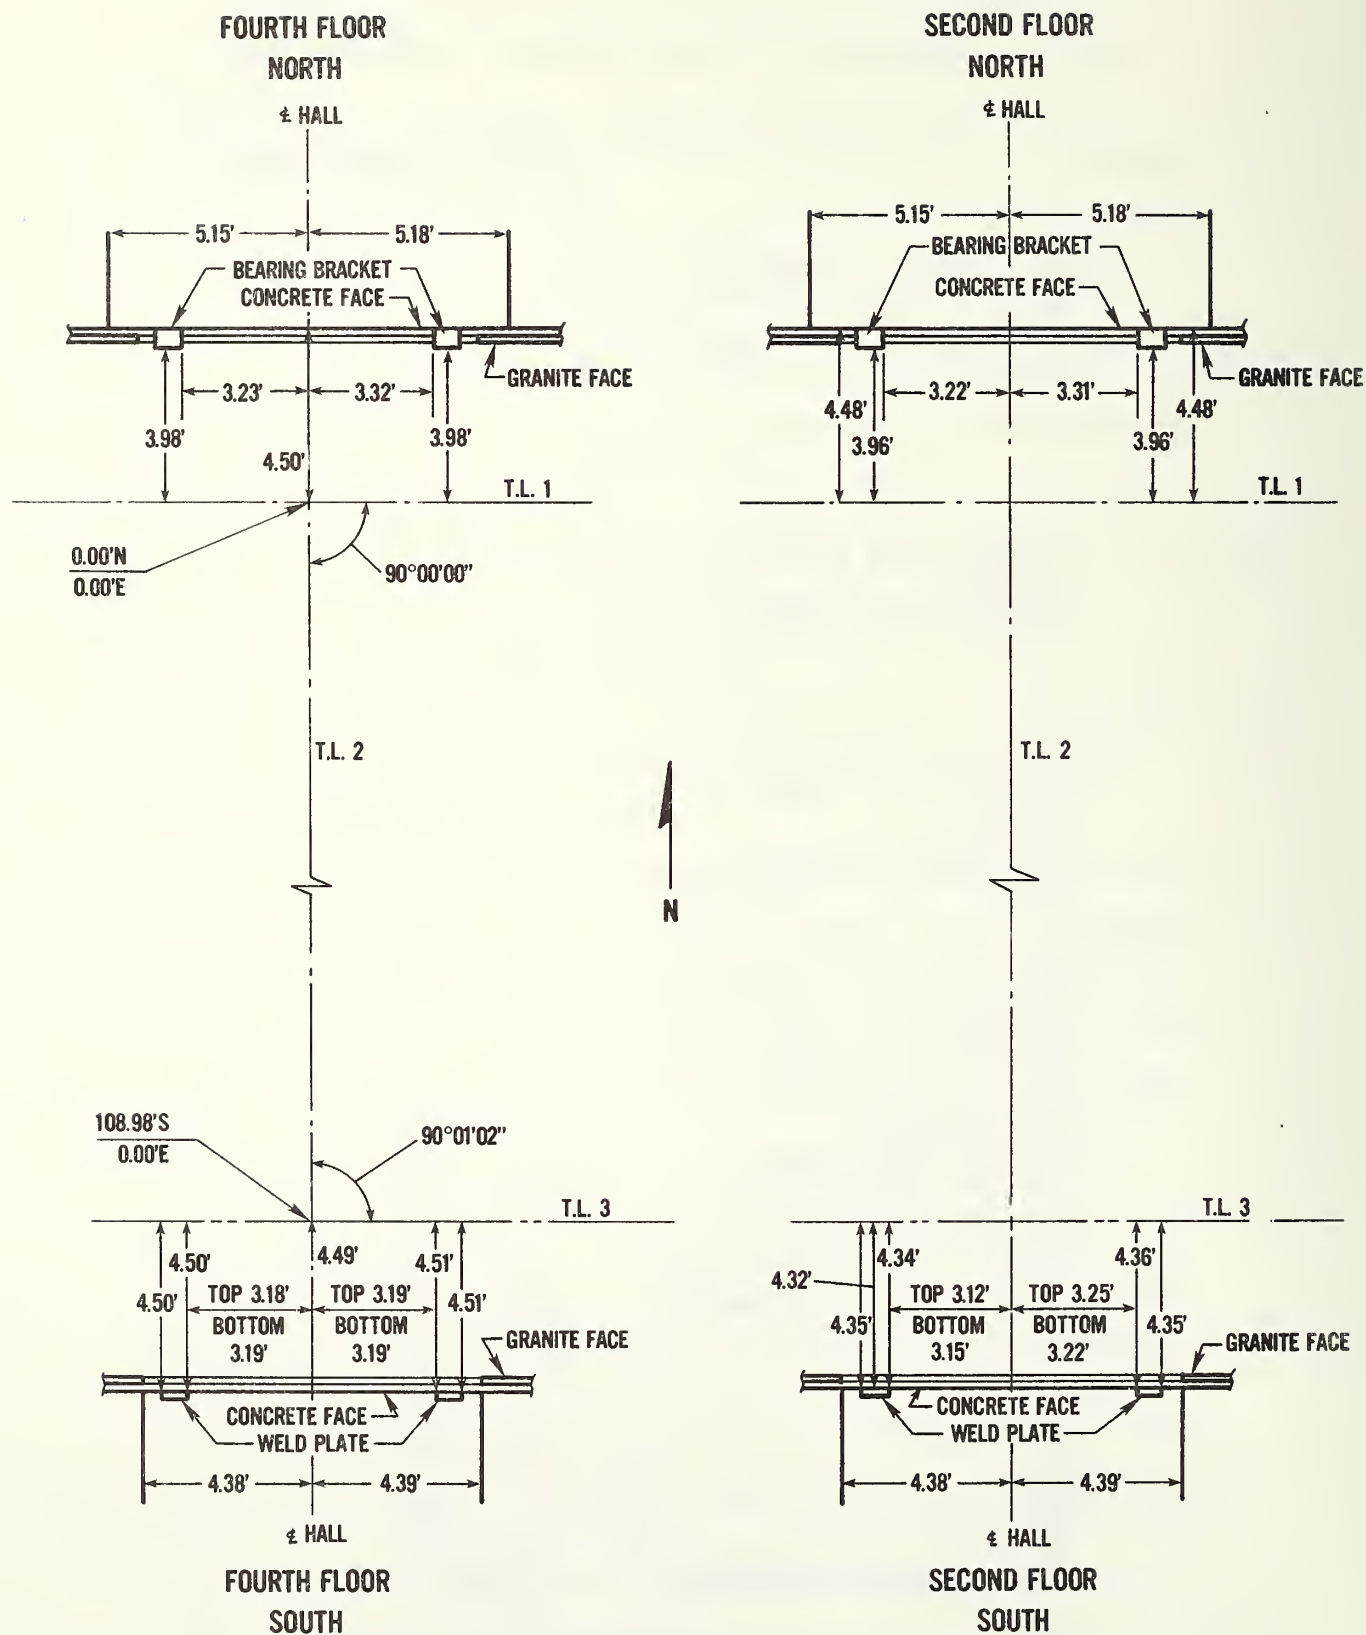
Locations of the embedded plates and wall openings at column line 7 (south) and the expansion bearing seats and wall openings at column line 11 (north) are shown in figure 5.1. It is apparent from figure 5.1 that the embedded plates at column line 7 on the fourth floor level (El.45.00 with respect to the datum of this survey) are approximately 0.15 ft (45 mm) south of the corresponding plates on the second floor level. As will be discussed subsequently, this misalignment required a retrofit of the bearing pads on the stringers of the north span of the fourth floor walkway (span U10-11). North-south alignment of the bearing seats at column line 11 is far better, the fourth floor bearing seats being 0.02 ft (5 mm) north of those at the second floor level.

Figure 5.1 Locations of embedded plates and bearing seats.

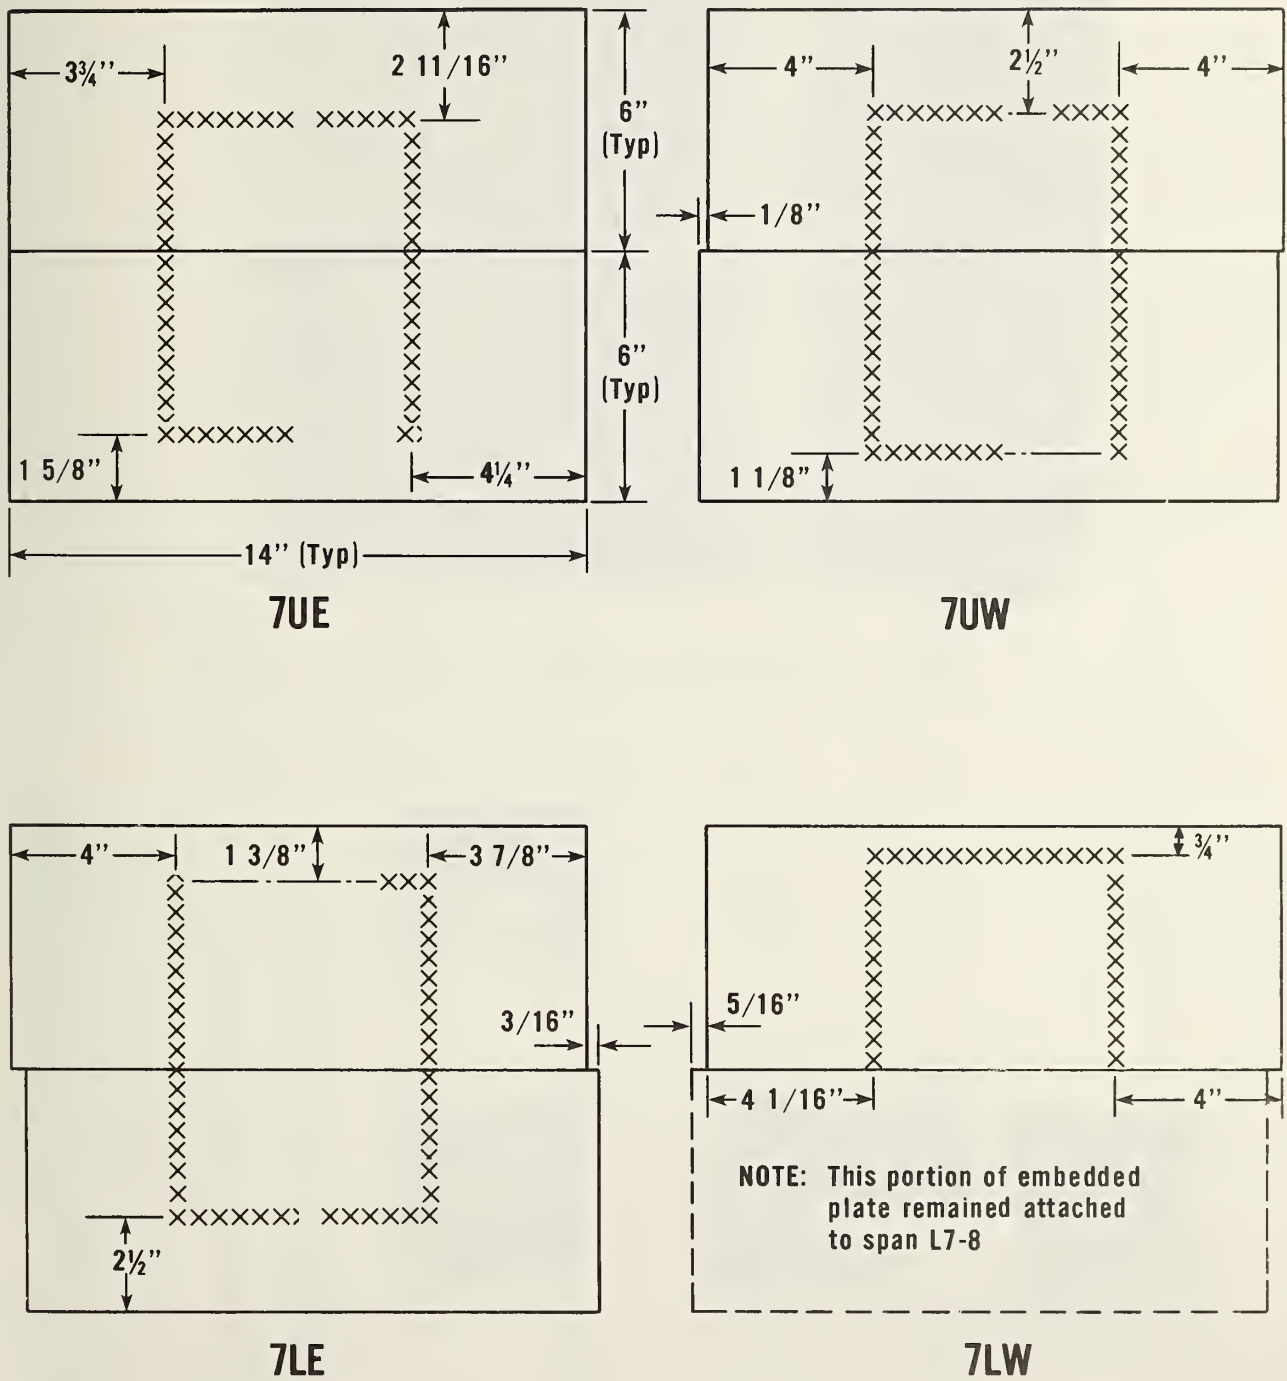
Each embedded plate at column line 7 is made up of two 1/2 x 6 x 14 in (13 x 152 x 356 mm) plates placed as shown in figure 5.2. Also shown in figure 5.2 are the locations of the fillet welds which made up the shear connection with the walkway stringers. Based on these dimensions, the east-west alignment of the walkways with respect to T.L. 2 at column line 7 was as follows:

Figure 5.2 Details of embedded plates and fillet welds at column line 7.

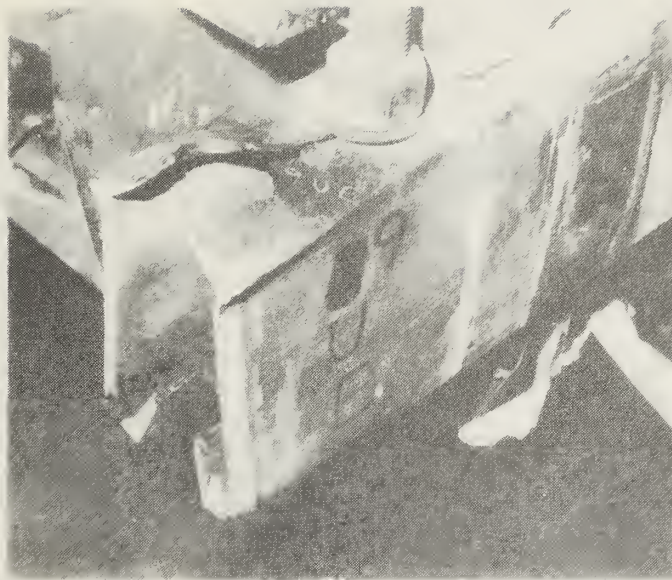
Figure 5.7 Hanger rod pull-through at location 9UE.

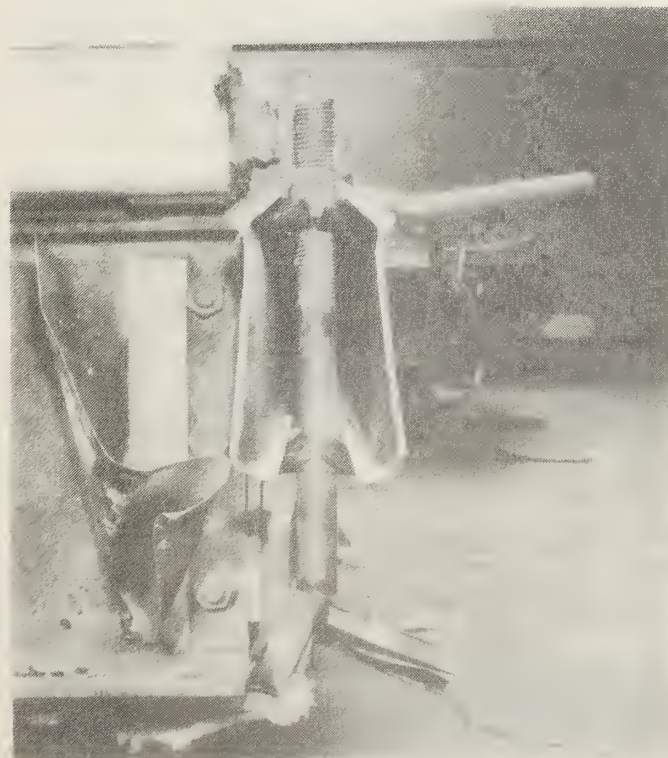
Figure 5.8 End view of box beam at location 9UE.

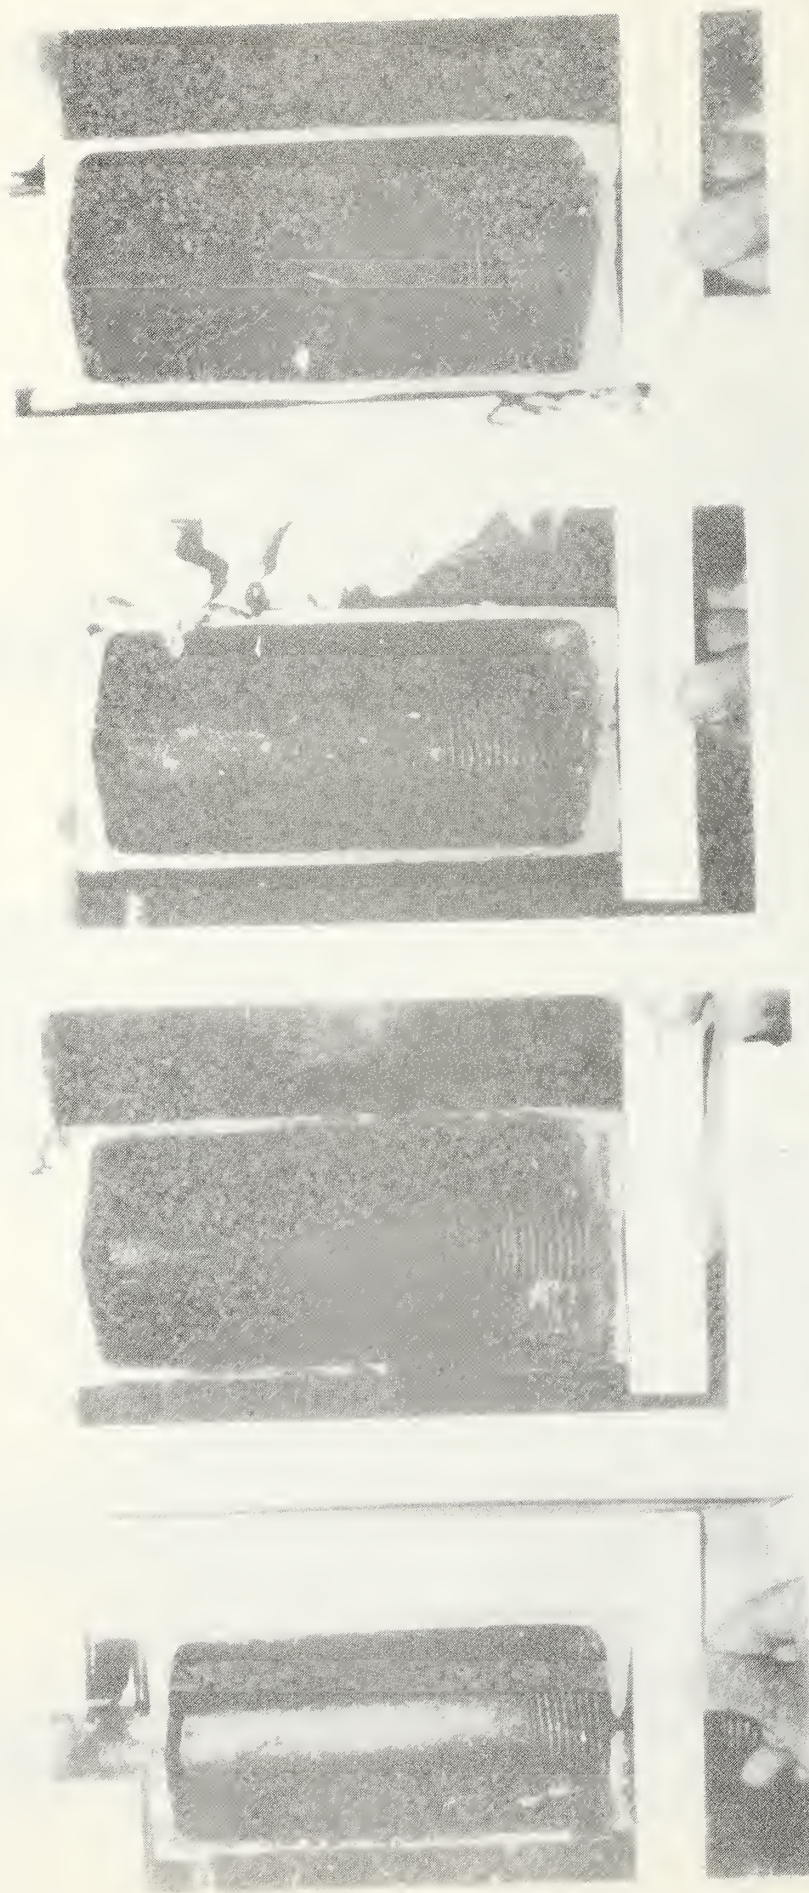
- a) Location 8MW.
- b) Location 8ME.
- c) Location 9MW.
- d) Location 10MW.

Figure 5.9 Evidence of permanent distortion in box beam ends of third floor walkway.

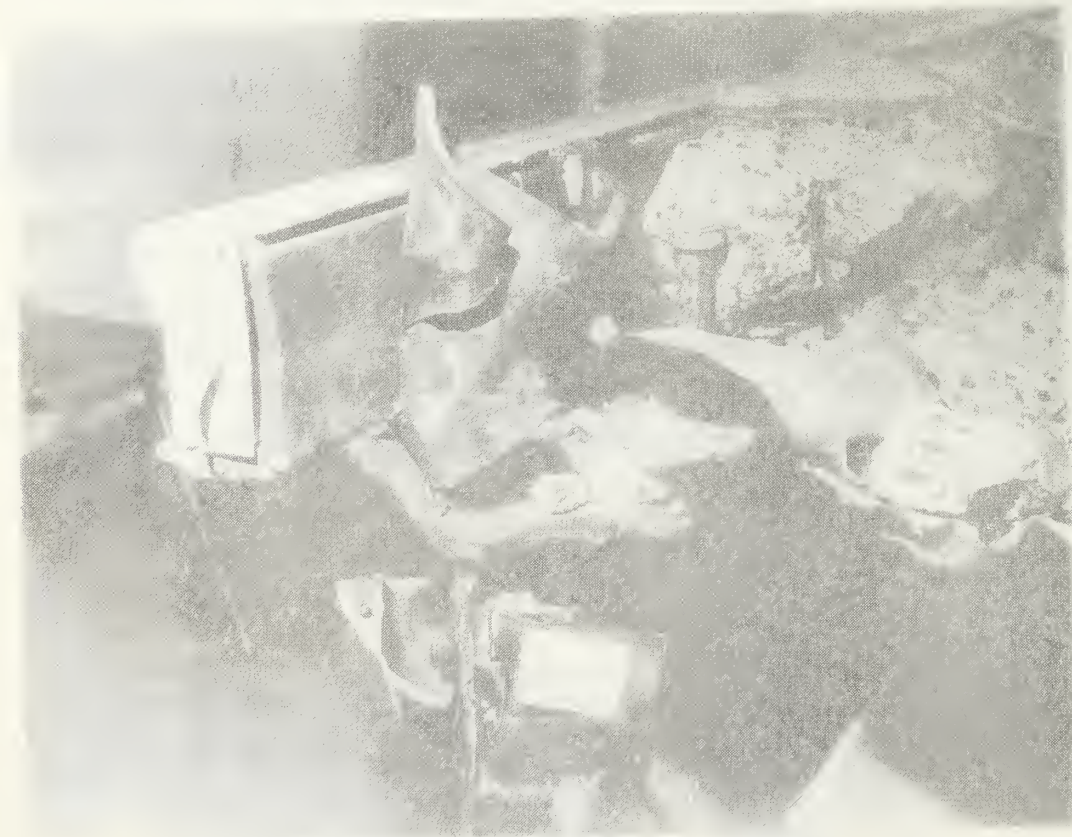
Figure 5.12 End view of 1/4" x 6" edging plate at location 10UW (Span U10-11).

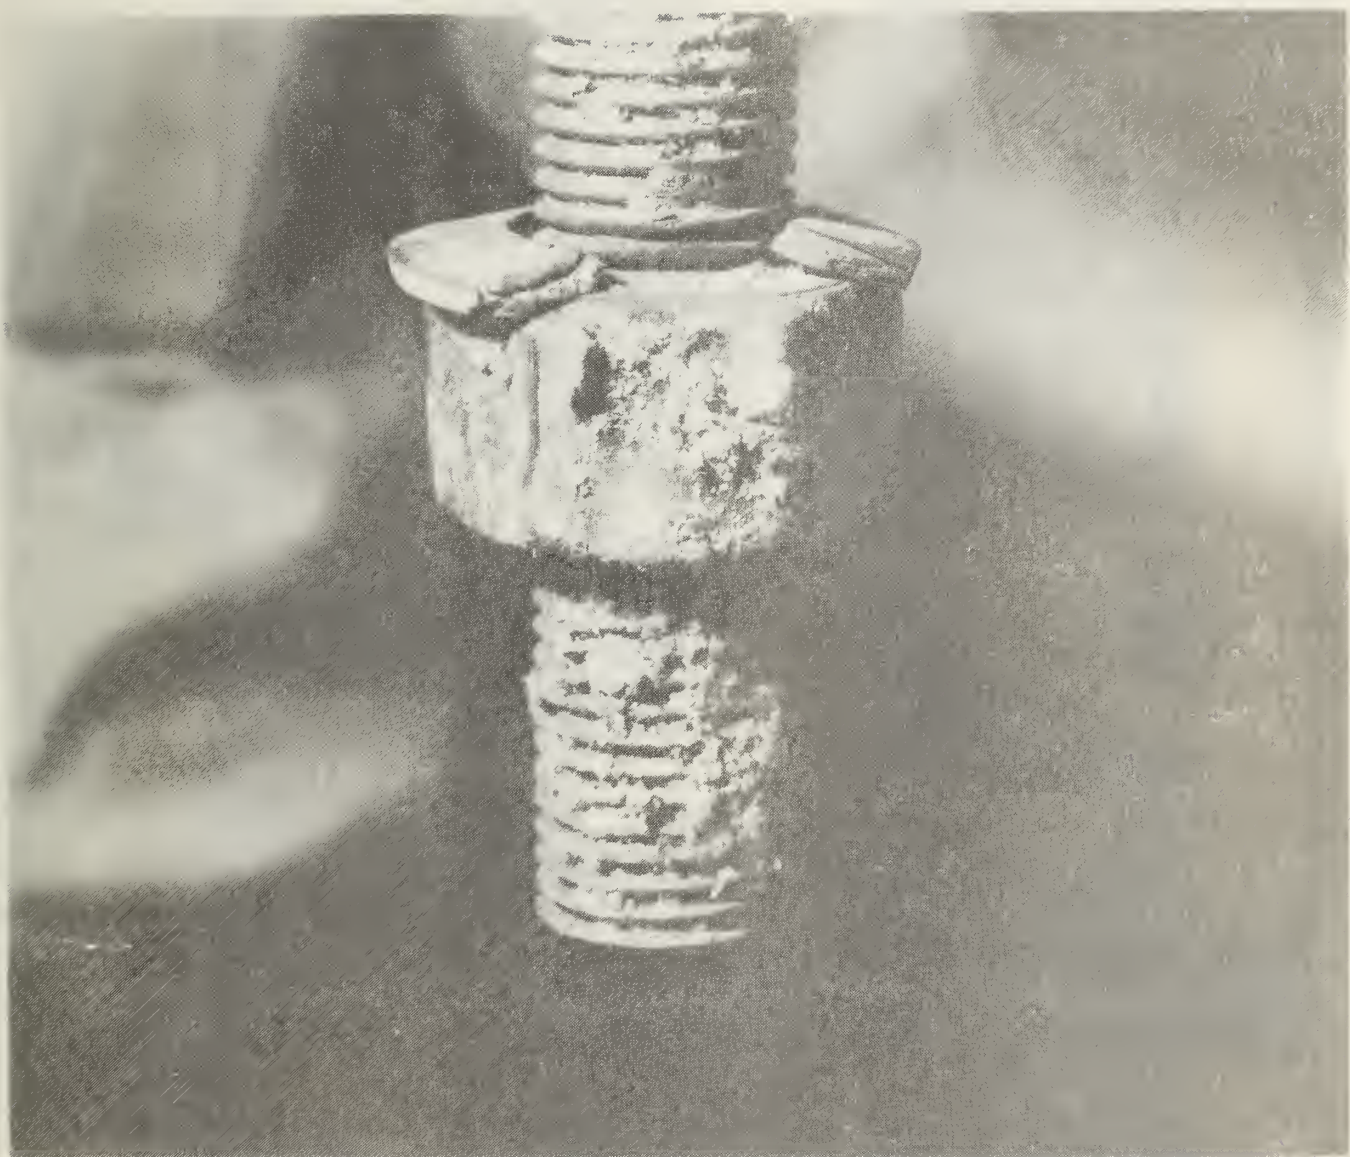
Washers were missing from the lower ends of the fourth floor to ceiling hanger rods at locations 8UE and 9UE. However, part of the washer at location 9UW was

Figure 5.13 Washer at bottom end of fourth floor to ceiling hanger rod 9UW.

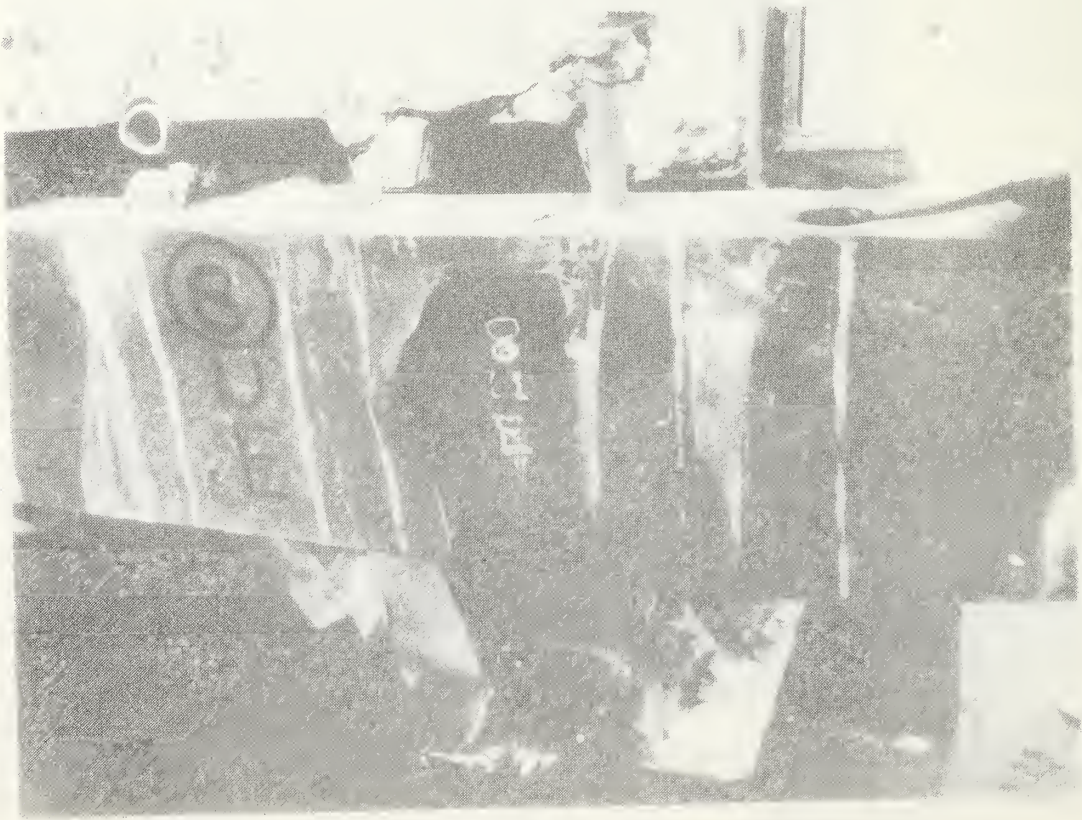
Figure 5.24 Tear in box beam web at location 8UE.

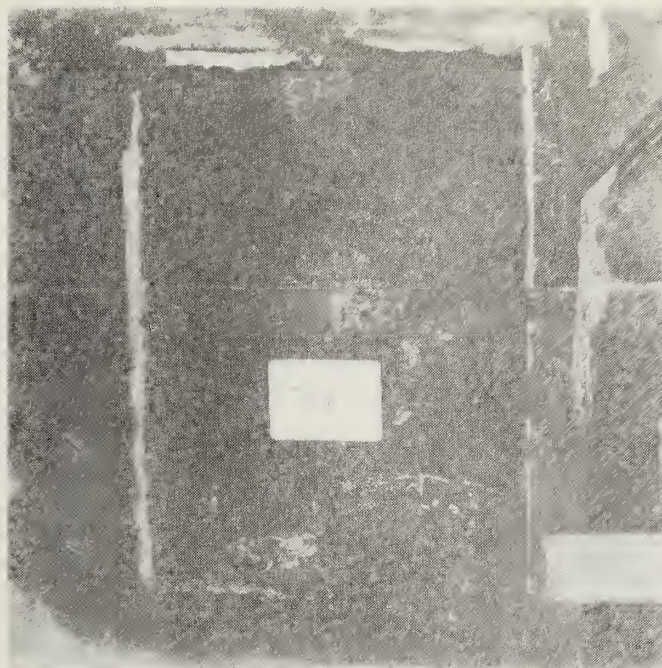
Figure 5.25 Embedded plate at connection 7UE.

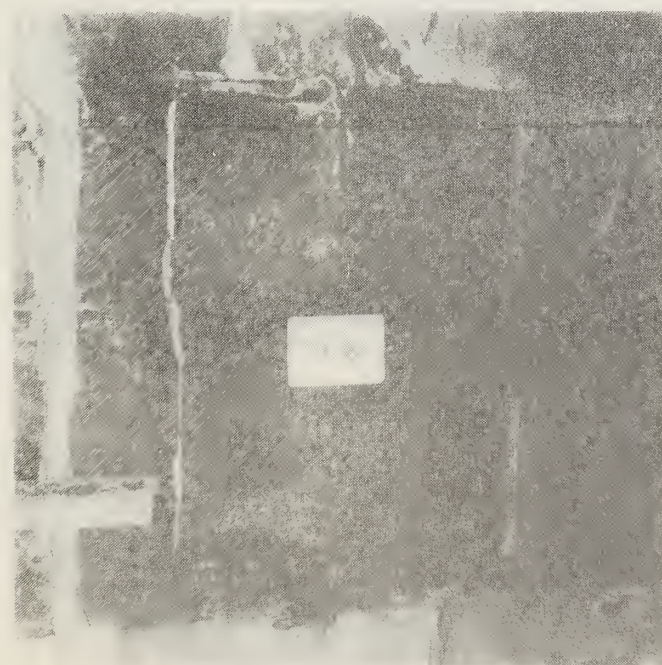
Figure 5.26 Embedded plate at connection 7UW.

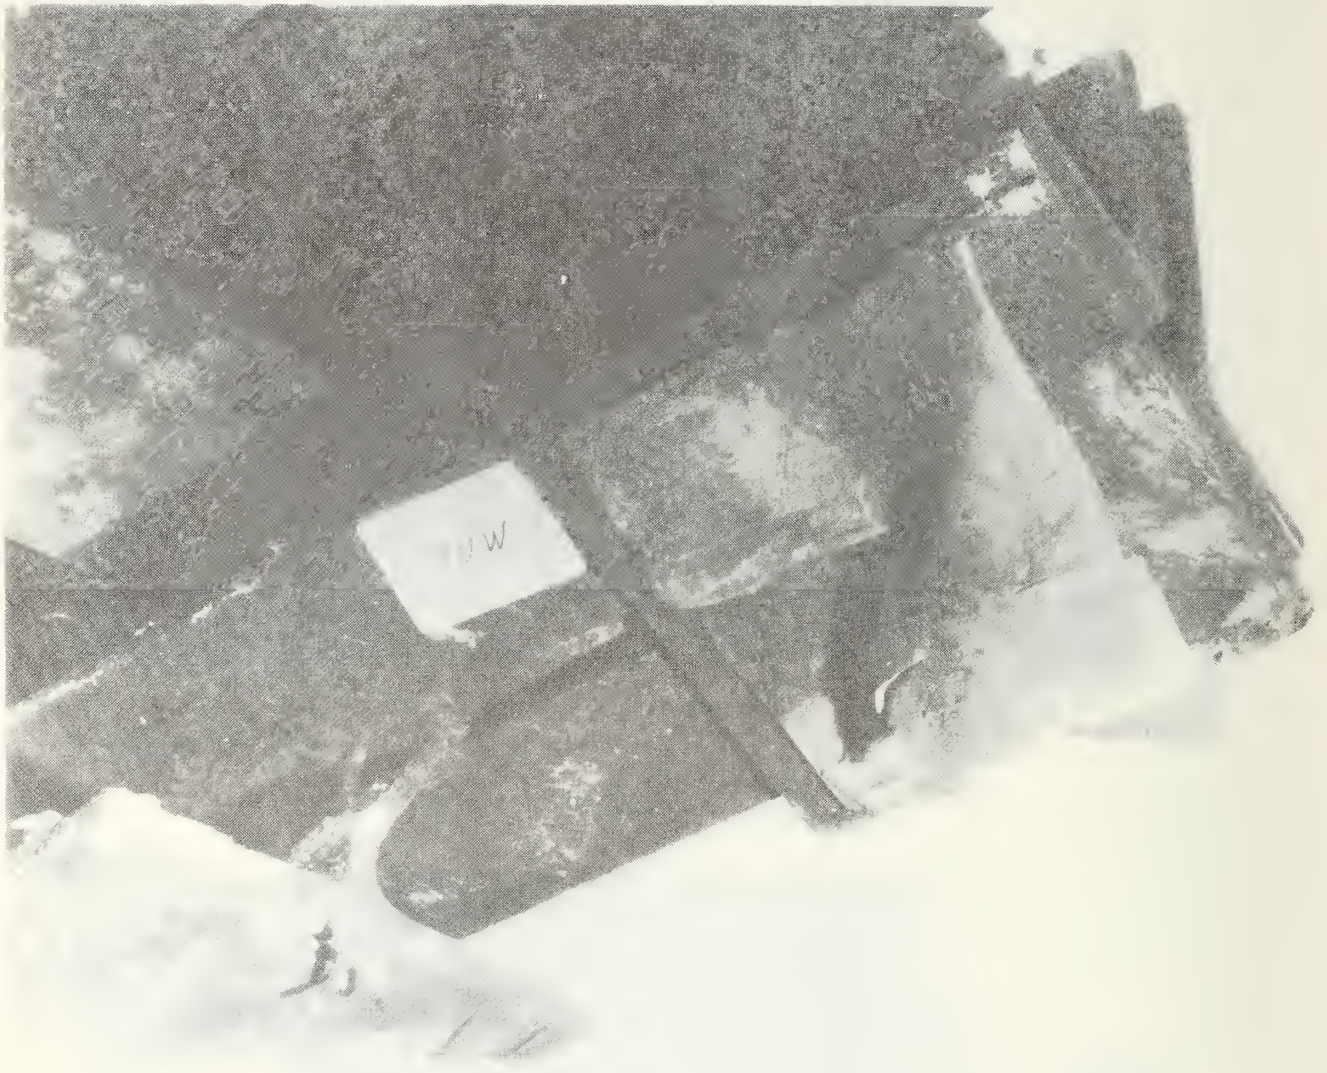
Figure 5.27 Modified bearing pad at location 11UW.

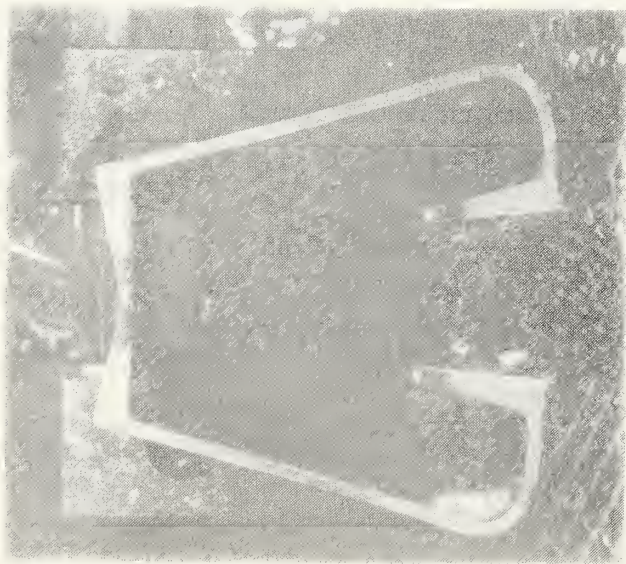
Type I Specimen K2

Three different failure types, assigned the identifiers I, II, and III, were observed and are shown in figure 6.14. The bottom flanges of specimen K2, and others exhibiting type I behavior, fold back about a plastic hinge in the web and do not show any discernible bending. The flanges in type III behavior, illustrated by J1, fold back about the plastic hinge in the web but also show pronounced bending in the flange. Type II behavior exhibits slight bending in the flange tips as illustrated by specimen M1. None of the washers fractured in these tests.

Figure 6.14 Deformed shapes.

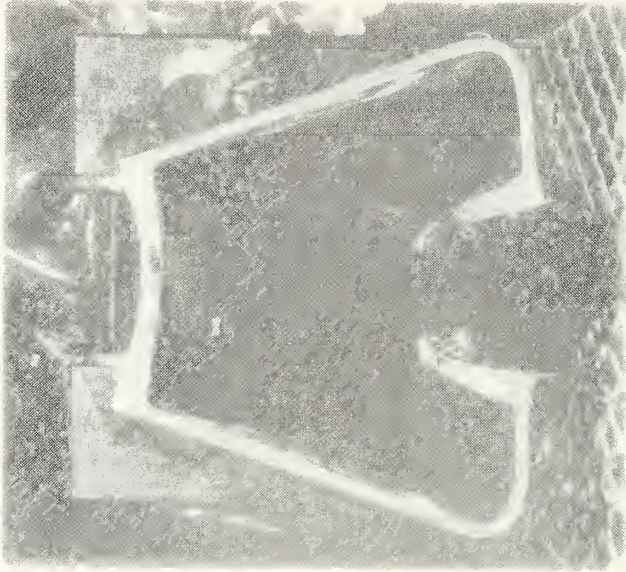
Type III Specimen J1

not yet fractured between the exterior hole and the beam end. The resistance to load decreases with increased deflection, but at a constant rate. The rate is quite similar to the load loss rate following the peak load in the type I behavior. The gradual loss in resistance to load continues with progressive cracking until the interior weld between the outer hole and the beam end fractures, at which point there is a sharp drop in load resistance. The bottom flanges exhibit pronounced bending as illustrated by specimen J1 in figure 6.14.
